# Qatar Islamic Archaeology and Heritage Project

End of Season Report

Spring 2013

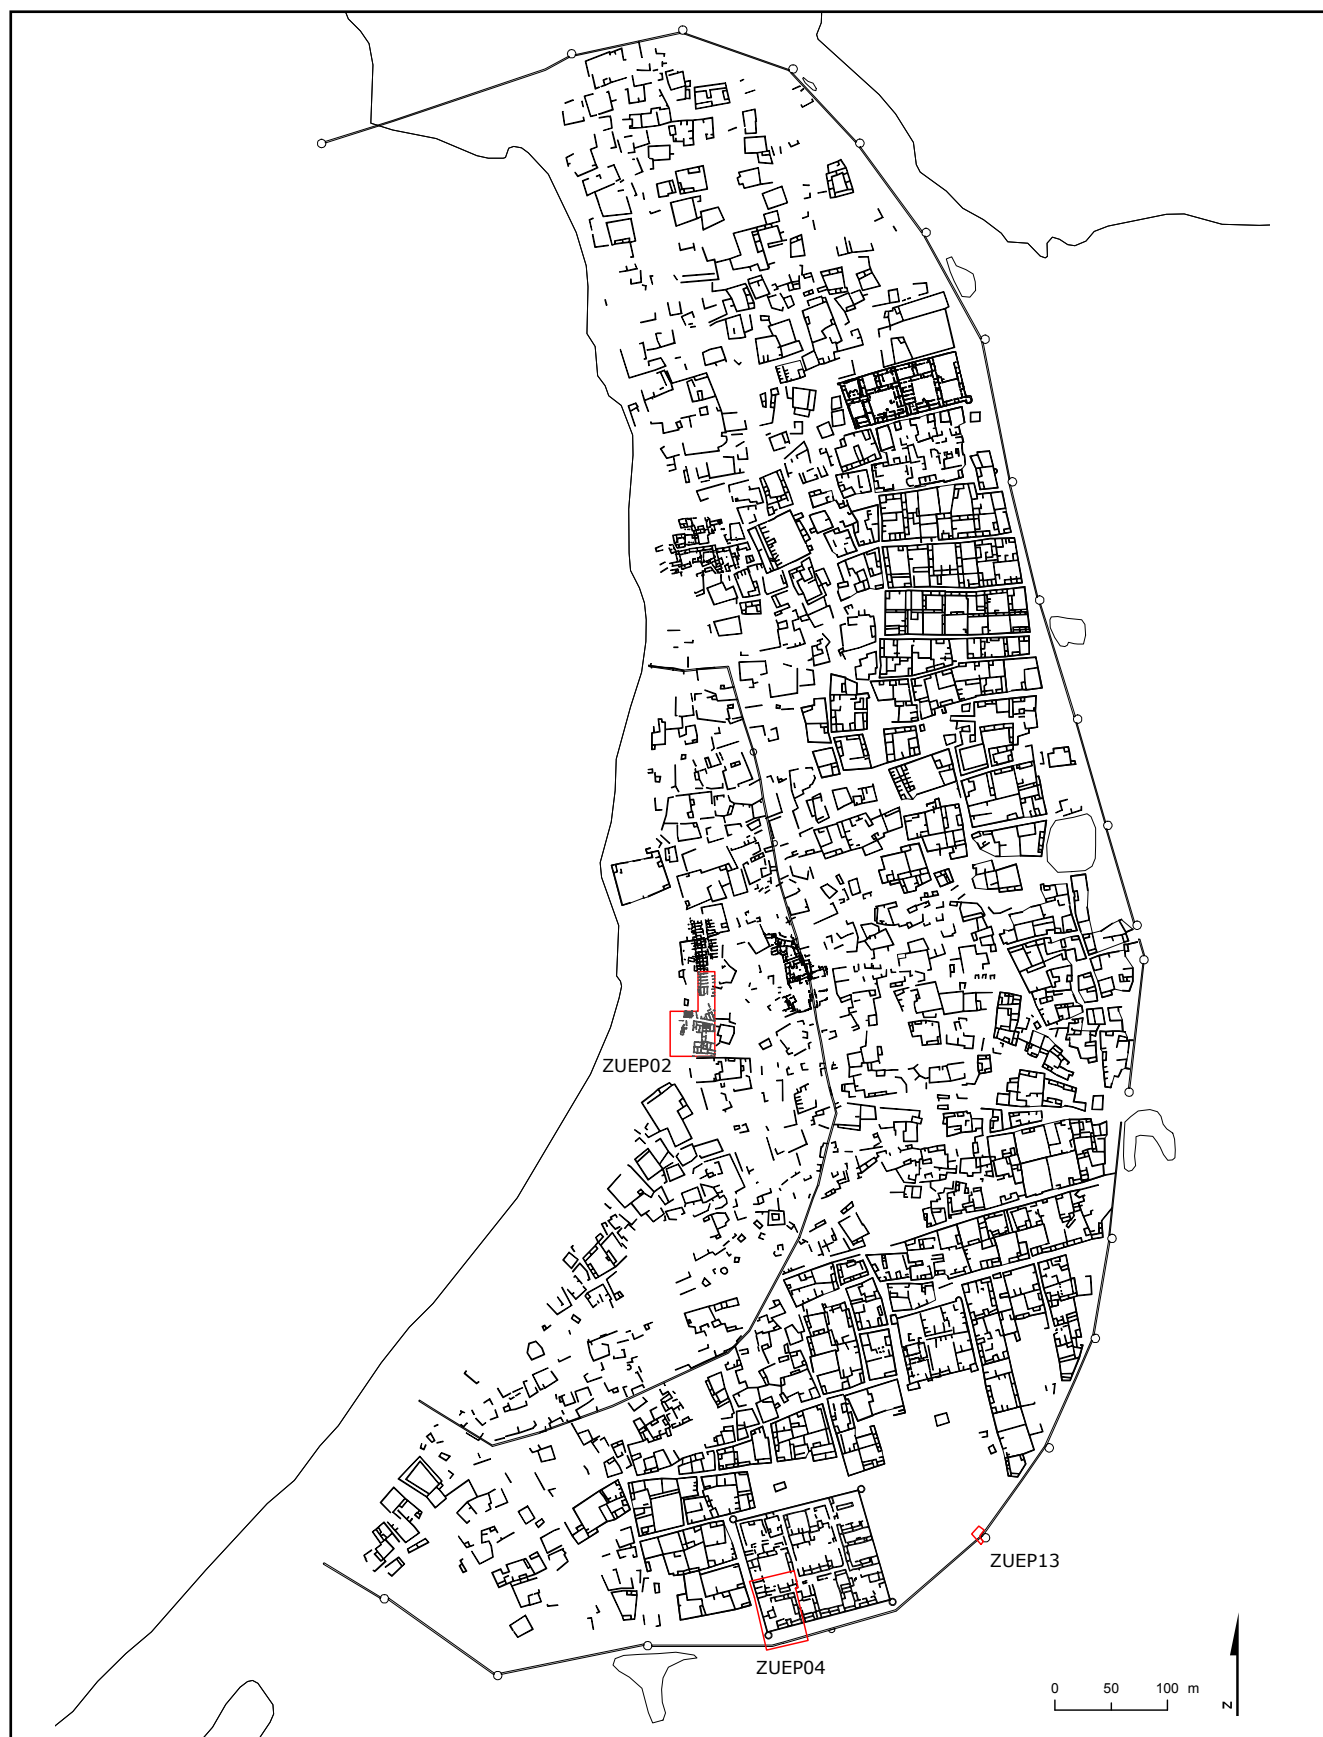
Figure 1.1: Plan of Al Zubarah showing areas excavated and conserved in spring 2013

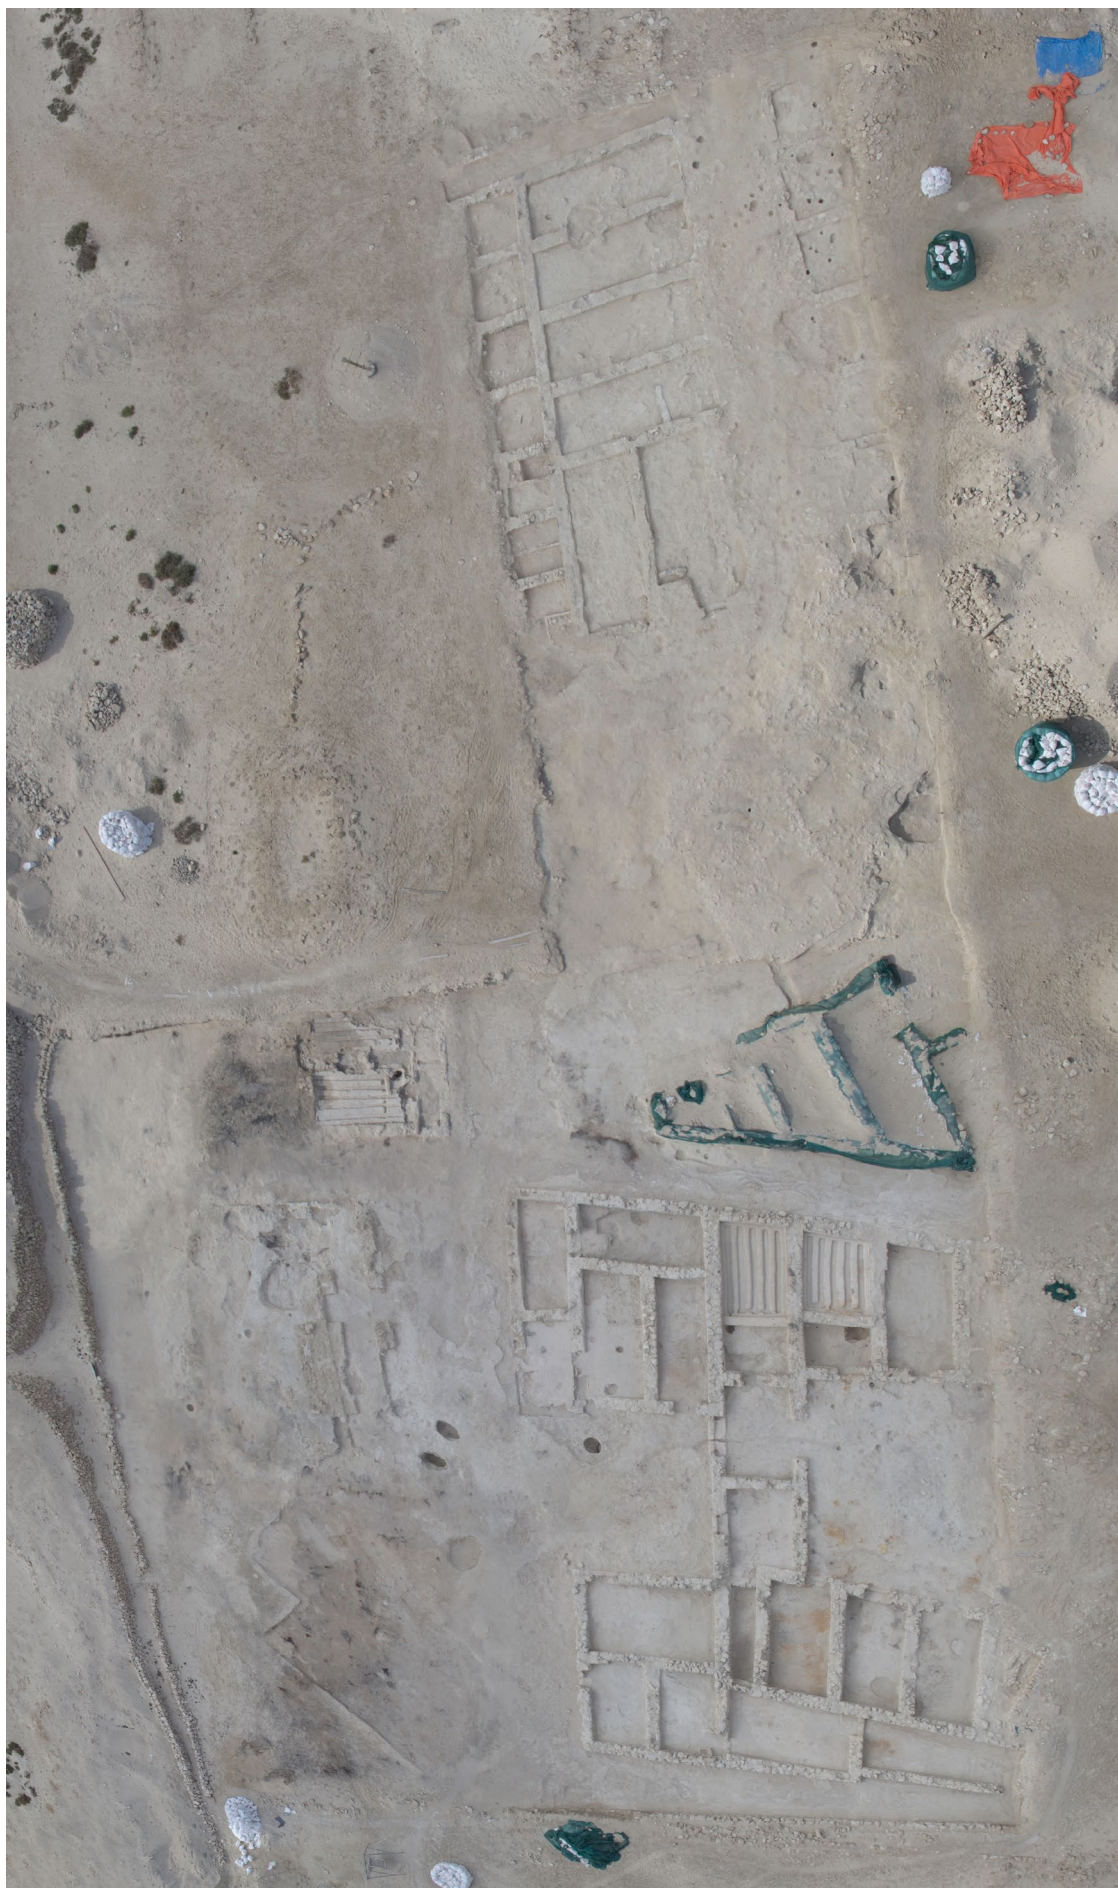
Figure 2.1: ZUEP02 Post-excavation kite photo. North at top. (IE-0513)

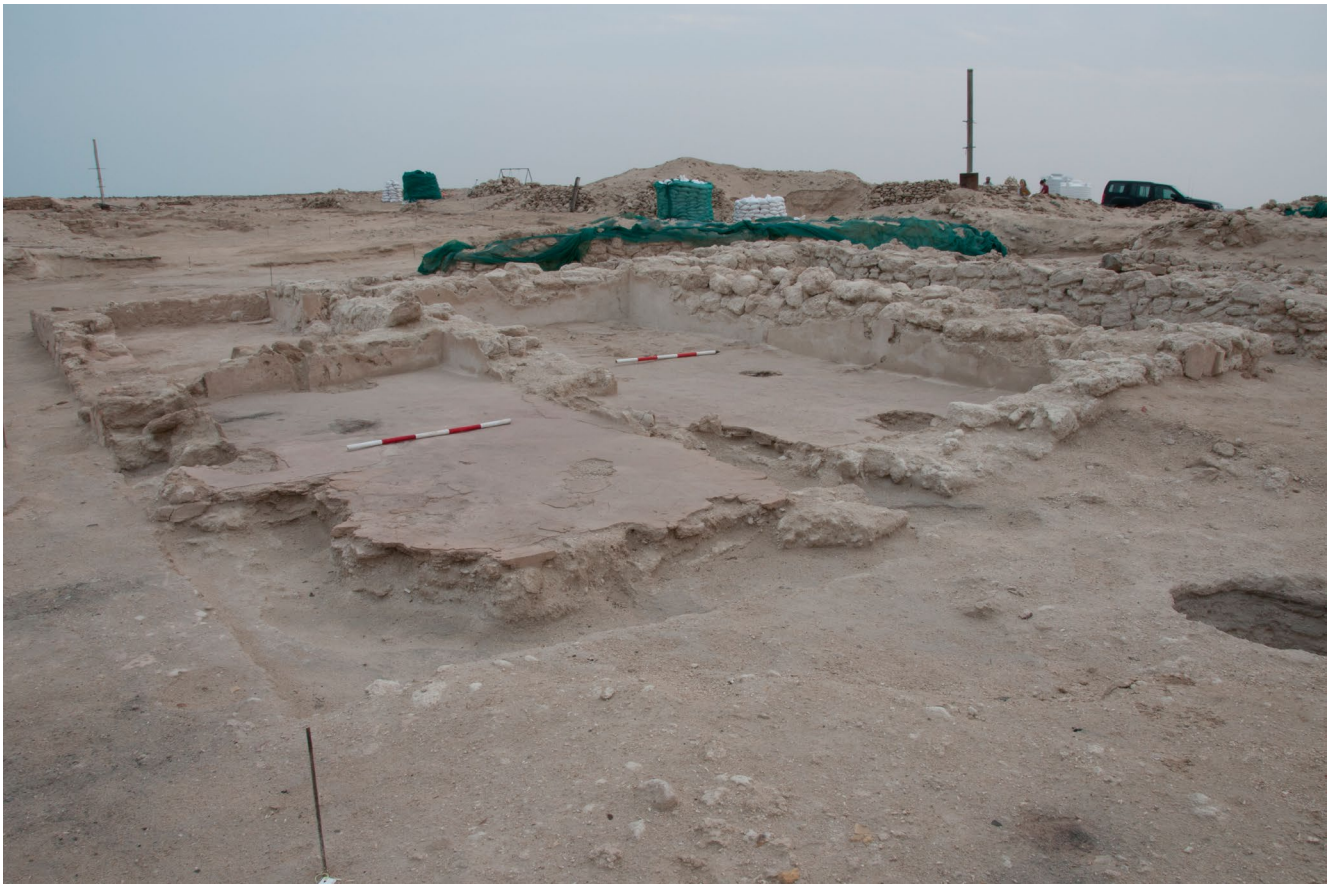
Figure 2.3: Spaces 69, 70 and 73 in the Eastern Area. Looking NW. (KE-0291).

Of the three final rooms excavated in this compound this season (Figure 2.3), Space 69 was the earliest, and with Spaces 62 to the east and 66 to the north formed a NW extension to the Main Compound. The room was plastered throughout, covering both floor surface and walls. An entrance to the space existed in its western wall, originally allowing access from the street (Space 72) and later into Space 70. The room had several features of note: located along the eastern wall were the scars of three evenly spaced plastered screens of unknown function (Figure 2.4); north of these, also projecting from the eastern wall, was a fourth, larger screen also leveled to the floor surface and only visible as a scar, effectively dividing the room. The floor surface beyond this point was highly fragmented. At the centre of the space was a small fire pit and at the southern limit a pit which may have initially housed a ceramic vessel sunk into the floor. Several red stains (Figure 2.4 insert) on the plaster surface of the room and on some of the ceramics removed from the overlaying deposits suggest that the space may have served a function related to the textile-dyeing industry. Part of the southern and western wall of the structure had been robbed for their stone most likely for preparation for the construction of the Phase 3 compounds. Within the rubble collapse interface with the floor surface were several fragments, now reconstructed, of a particularly striking incense bowl; this is thought to originate from Oman (Figure 2.5).

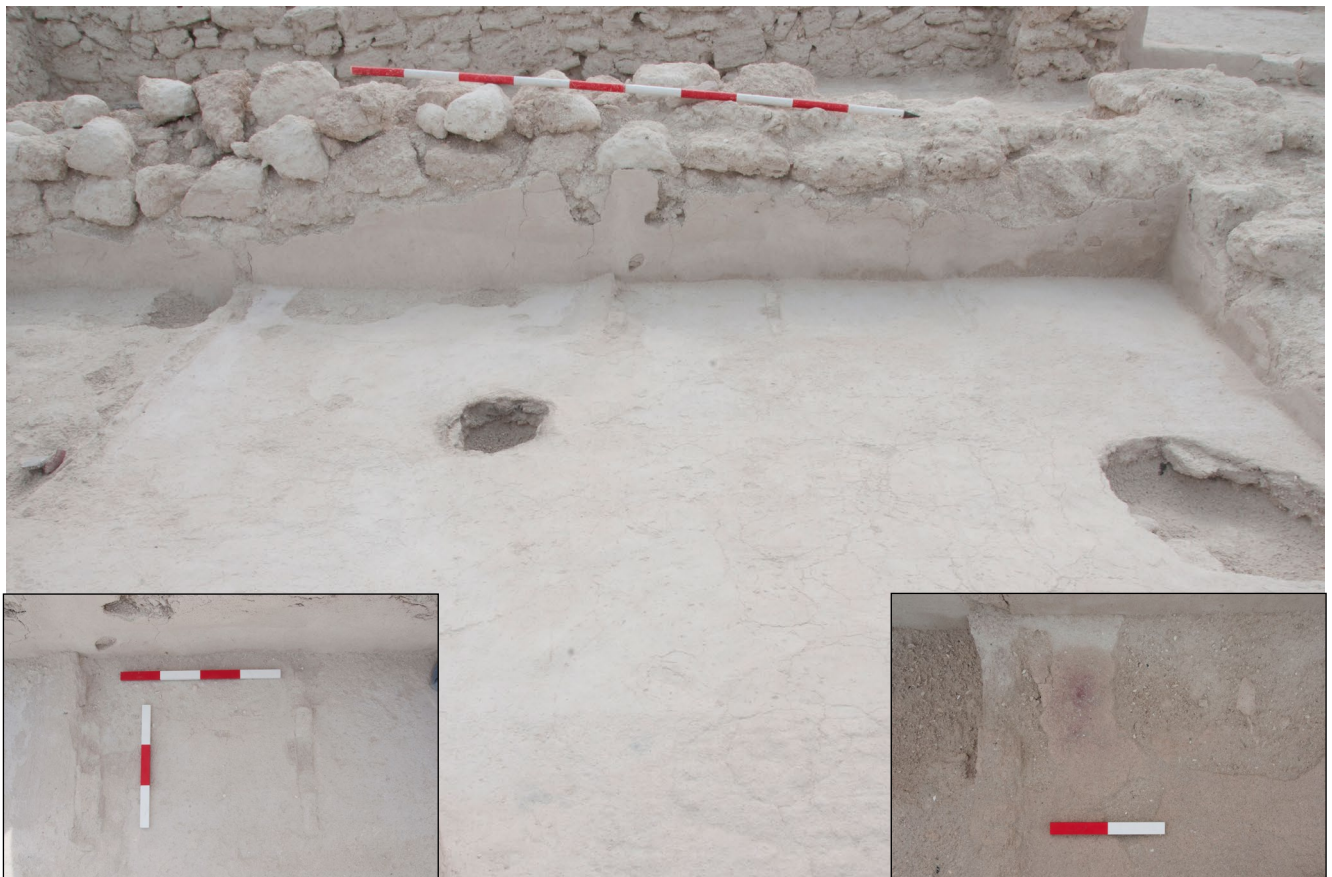
Figure 2.4: Space 69 plaster feature scars on eastern wall (KE-0187), with a detail overview at bottom left (KE-0188) and red staining on plaster surface at bottom right (KE-0301)

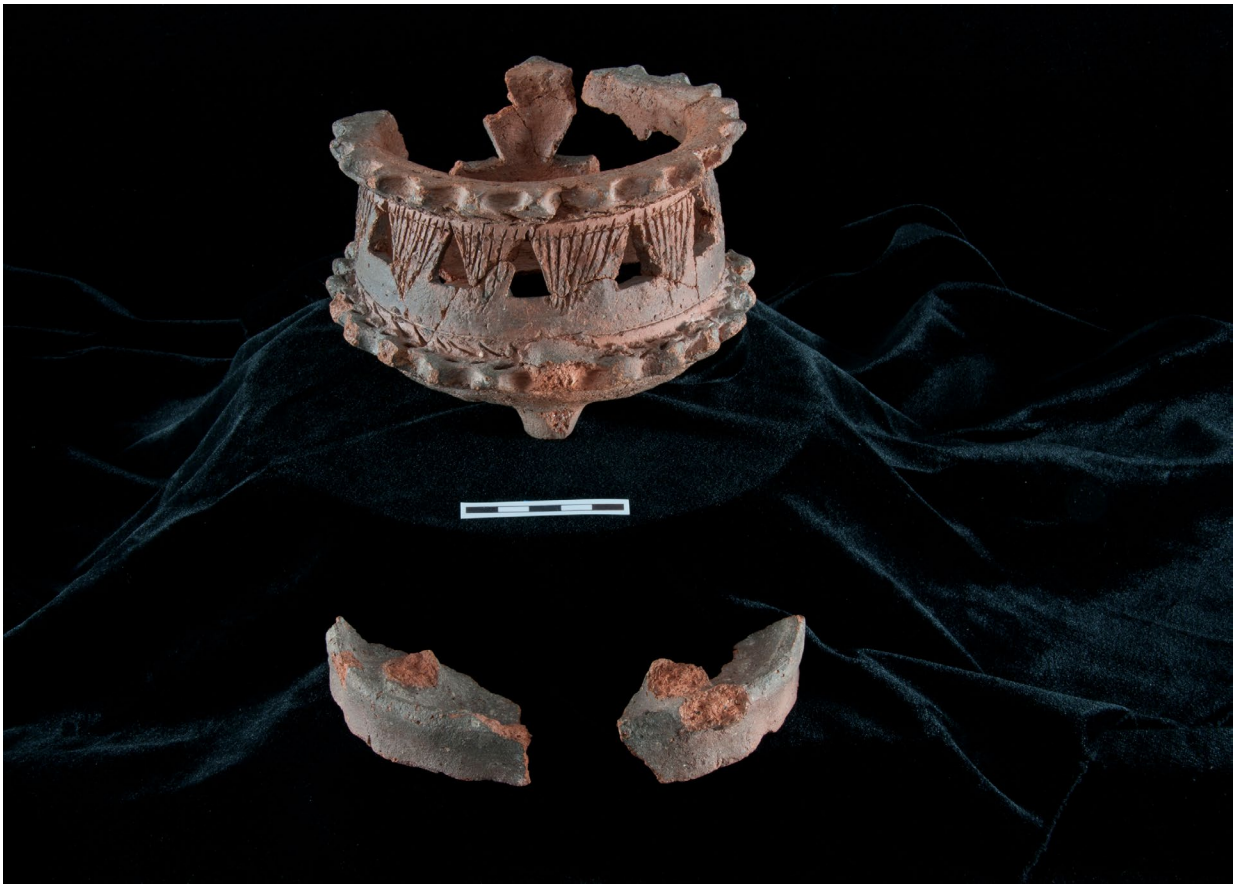
Figure 2.5: Pierced Incense Bowl, Oman (OE-2532)

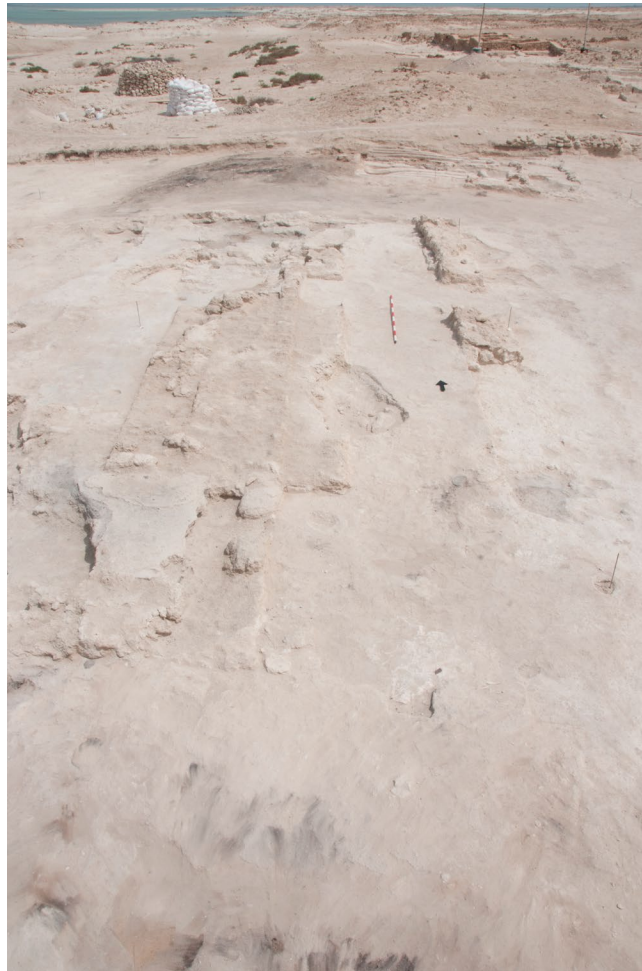
Figure 2.6: North-facing view of beachfront structure Spaces 83 and 84 (KE-0200)

The limited survival of this intriguing structure has led to several working theories. The exposed extant structure appears to consist of at least two distinct spaces: a possible stairwell allowing access to a roof, and an adjacent long, narrow room (Figure 2.6), which appears to have been open at either end and was possibly a covered walkway (Space 83). The stairwell appears to have been accessed to the south from an external space or courtyard (Space 84) which extends

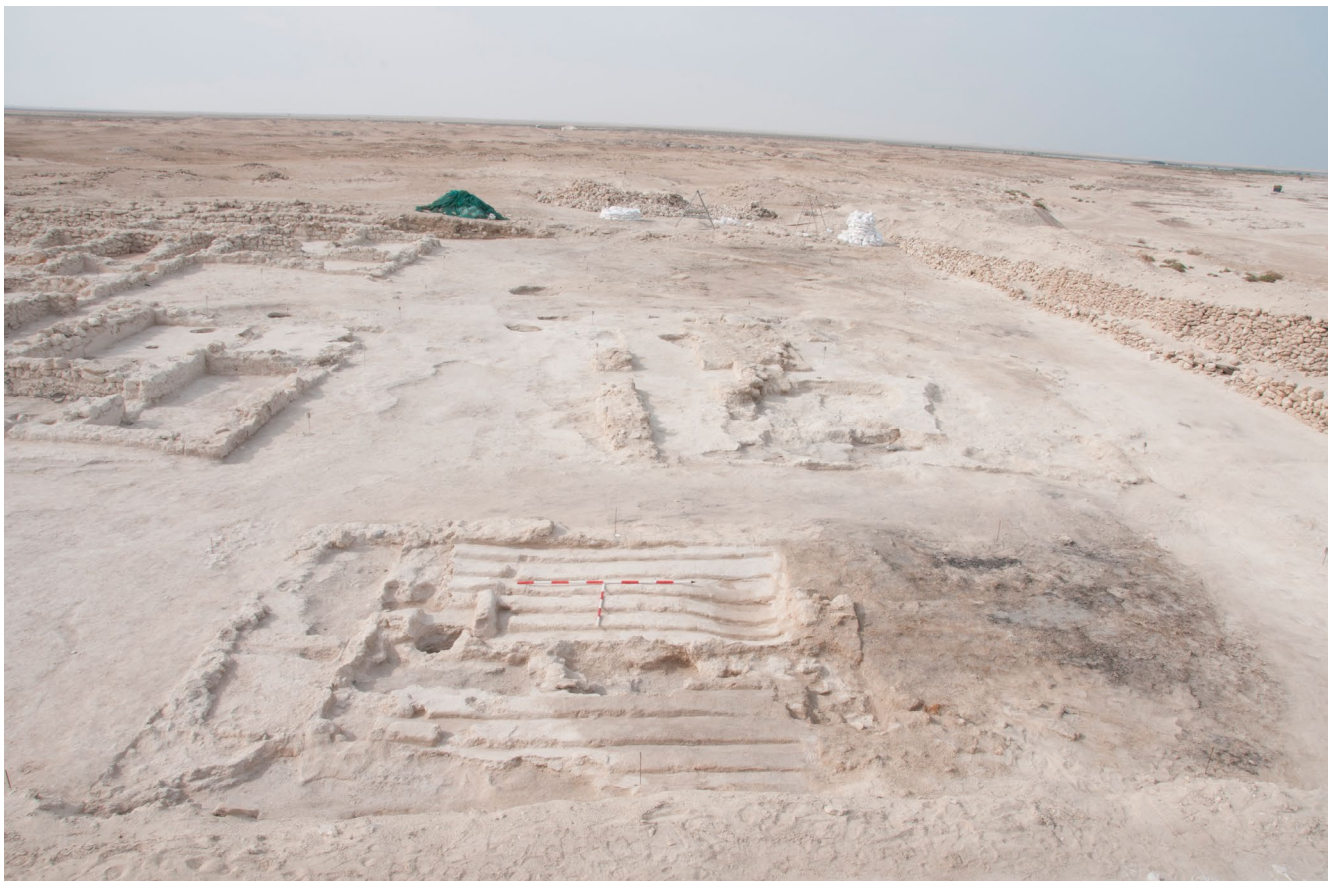
Figure 2.7: South-facing view of the double date press Space 82 (KE-0170)

To the north of Space 83 and 84, separated by a thoroughfare that was likely an extension of the street (Space 3), were two date presses (Space 82). These were highly truncated by Phase 4 pitting (Figure 2.7). The front of the structure appears to have been open with a stone kerb and metalled walkway formed of angular, fist-sized or smaller stones, making a rugged surface; many of the stones showed evidence of burning, and a majority were of a hard quartz or chert material unusual for the area, suggesting a specialised function. The *madbasa* structure appears to have been constructed over an earlier pit and has suffered from subsidence. Located within the SW corner of the plastered collection tank associated with the date press was a concentration of broken ceramics clearly representing a single vessel with red fabric and slip decoration around the rim and body. It was likely this vessel was used to decant the date syrup (*dibs*).

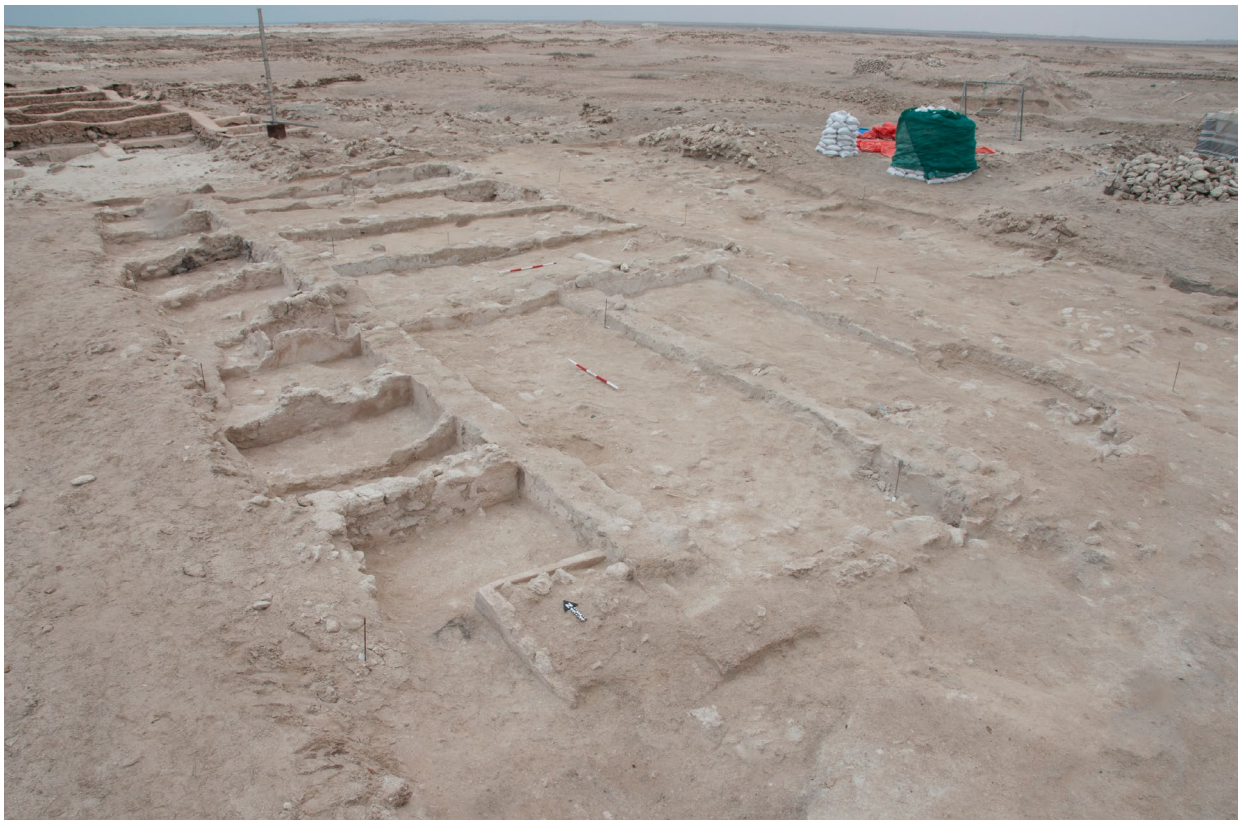
Figure 2.8: Northwest-facing view of the Northern Extension showing the emerging architecture of the *souq* and the previous excavation area QMA1 in the background (KE-0289).

The removal of rubble and deposits from Phase 3 and 4 revealed a wide north to south aligned street separating two blocks of rooms mirroring the northern *souq* (QMA1) and divided from it by a narrow east to west alleyway (Space 79). Initial removal of some of the room fills allowed for a greater resolution of the architectural layout of the *souq* as well as a glimpse of the possible function of some of these spaces, with at least two showing the markers of a date press in the form of an off-centre plastered kerb wall dividing the date press from the catchment room. This indicates that at least some of the *souq* may have been used for the storage and processing of dates (Figure 2.8).

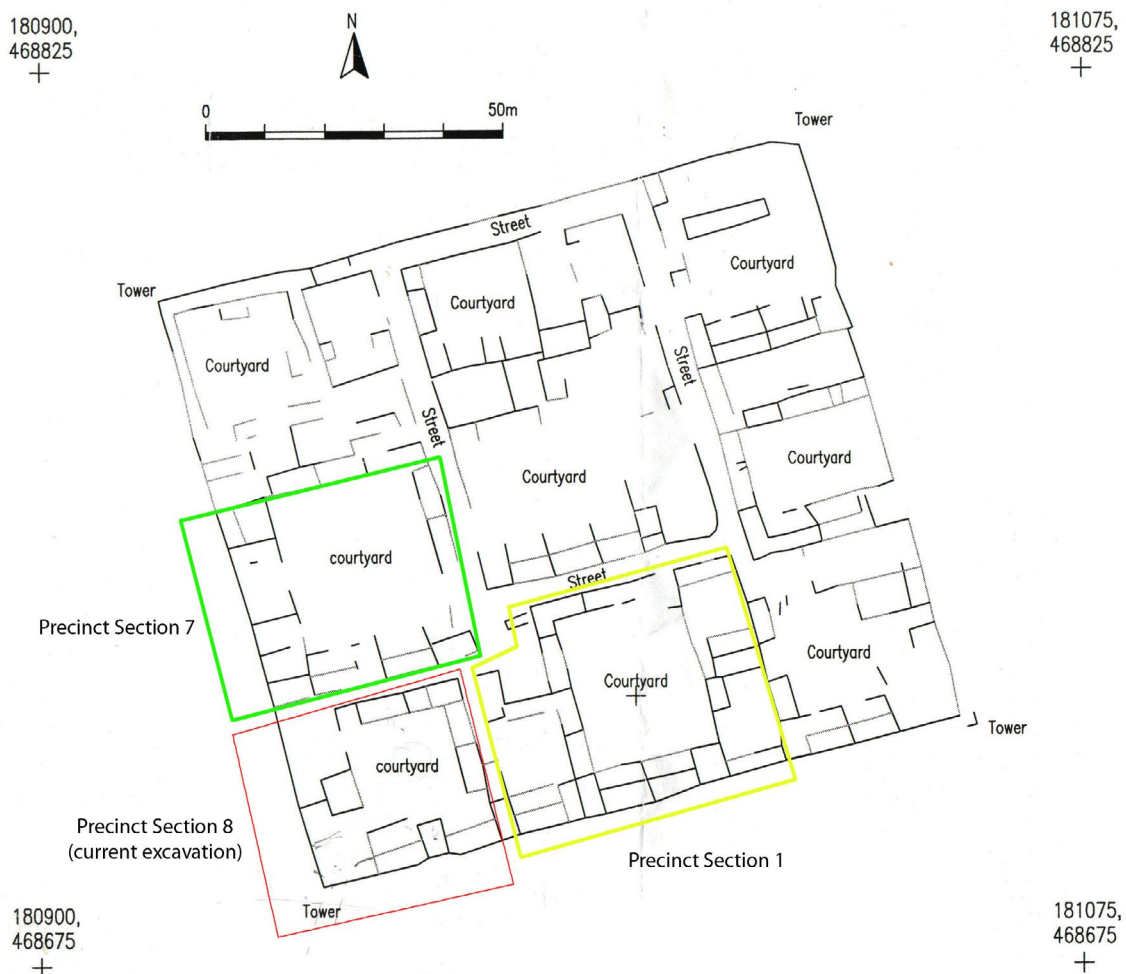
Figure 2.11: ZUEP04 - Plan showing precincts

Excavation Point 4 (hereafter ZUEP04) is located at the southern end of Al Zubarah (Figure 1.1) and focuses on a large fortified compound enclosing rooms and courtyards supported by parameter walls with corner towers. This compound was divided into eight separate Precinct Sections (PS) surrounding a centralised courtyard, which was circumnavigated by streets and passageways (Figure 2.11).

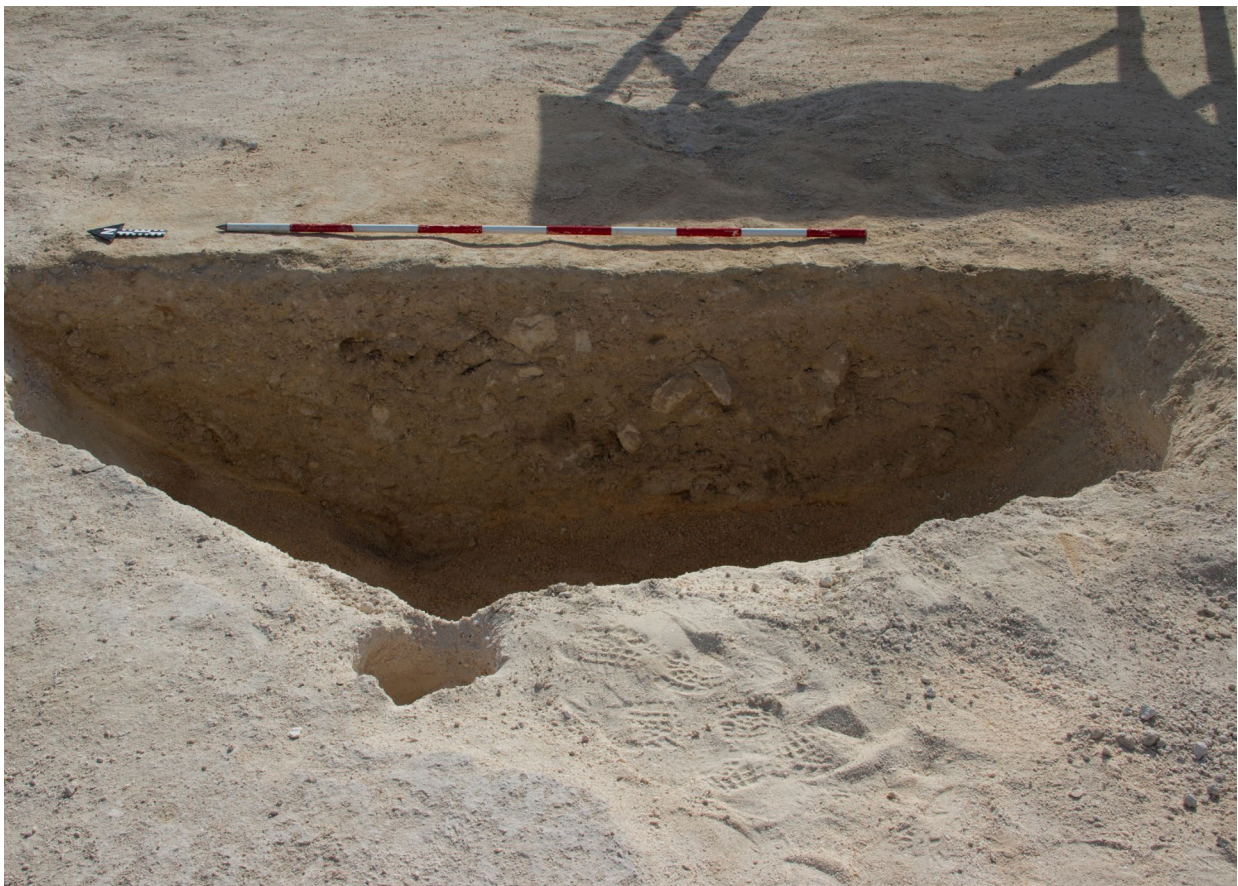
Figure 2.13: Colossal pit [4910], looking east, in courtyard Space 3012. (ME-0367)

The excavation of the courtyard surfaces was dominated by the presence of massive pits, some measuring 3m in length and 1m in depth (Figures 2.13 and 2.14). The existence of these huge truncations was initially inexplicable, and the first avenue of exploration concerned the purpose of their construction. It seemed reasonable to think that such large pits would have contained some form of domestic and organic waste. However, this was not the case: finds were rare

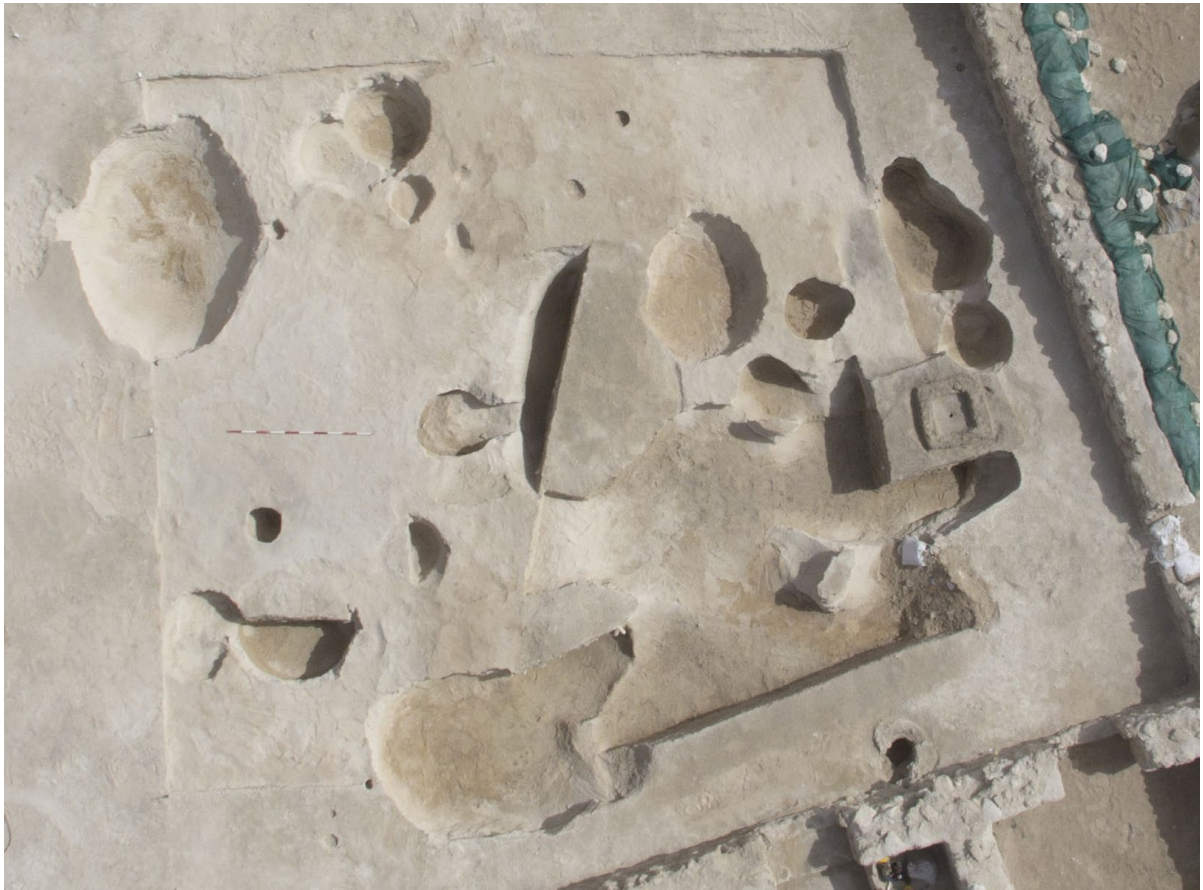
Figure 2.14: Post excavation shot of 10 x 10m sondage cut through construction horizon (4731) in courtyard space 3012 showing truncations, aerial view. South at top. (IE-0140)

indeed. The pits had been dug and then merely backfilled with discoloured shell and sand. They were possibly originally cut to extract clean shell and sand from the underlying natural deposits. This material would have then been used to produce and renew clean shell surface layers for rooms within the compound. It may have also been used to construct the composite beach stone used to build architectural features within PS8 itself.

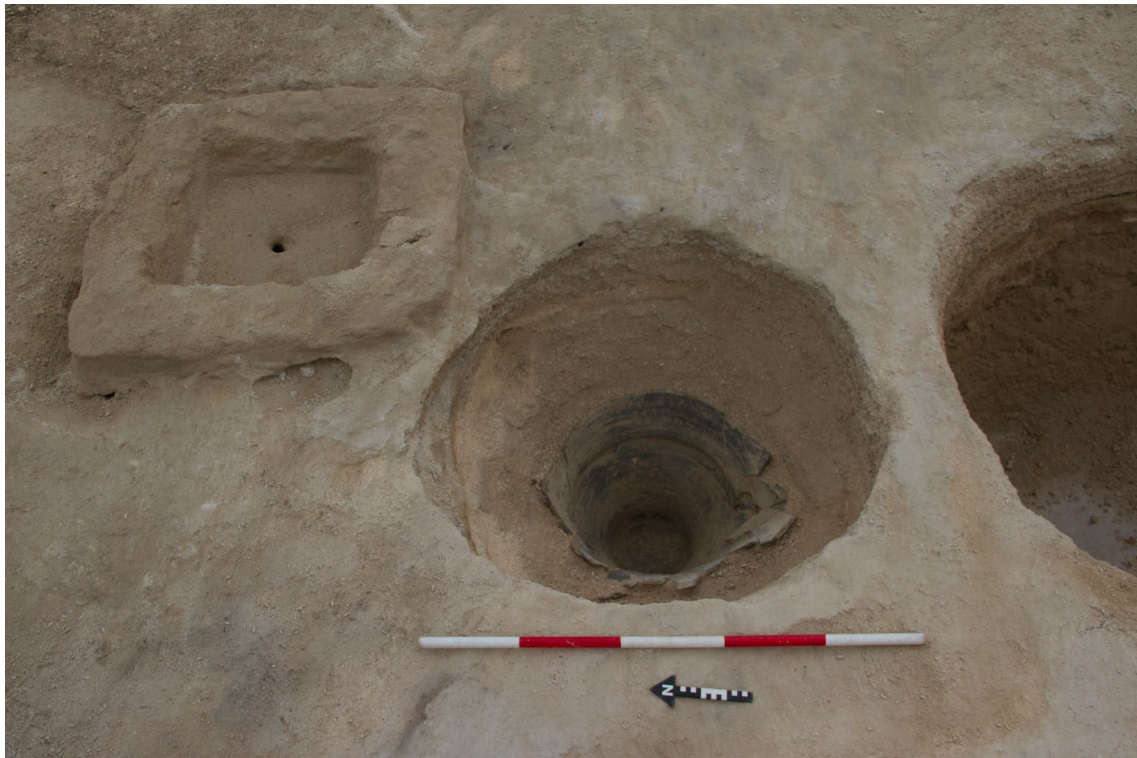
Figure 2.15: *In situ* water jar <4830> residing in pit [4833] in Space 3012 immediately southwest of water basin <4391>, looking east. (ME-0144)

Other pits found in the courtyard sequences proved more interesting and less ambiguous. Circular pit [4833] contained the base remnants of a large jar believed to have contained water (Figure 2.15). The upper main body of the pit contained large amounts of large smashed fragments of this jar, but also weathered plaster fragments and large beach stone pieces. The jar had been smashed and then backfilled with unwanted stone and plaster material. It is intriguing for many reasons. In the first instance, it showed that stone and other degraded architecture had been thrown into an unwanted storage jar pit, presumably to fill it with hard and sufficiently stable material to provide a surface in line with the rest of the courtyard. It is notable that little material culture remains and domestic waste were found inside. Secondly, the

pit bears resemblance to other circular truncations that were similarly filled with grey sand and shell, suggesting that circular pits found elsewhere in the courtyard may have also housed such water jars. These truncated the courtyard below ground level to keep the liquid cool and also to provide a stable position and location – the jars seemed too large to stand upright on their own. Thirdly, this circular cut was directly to the southwest of water basin <4391> found initially in season 2010. This would suggest that both the water jar and the water basin could have been used contemporaneously, the jar for water and the basin as a washing space with associated drainage (Figure 2.16).

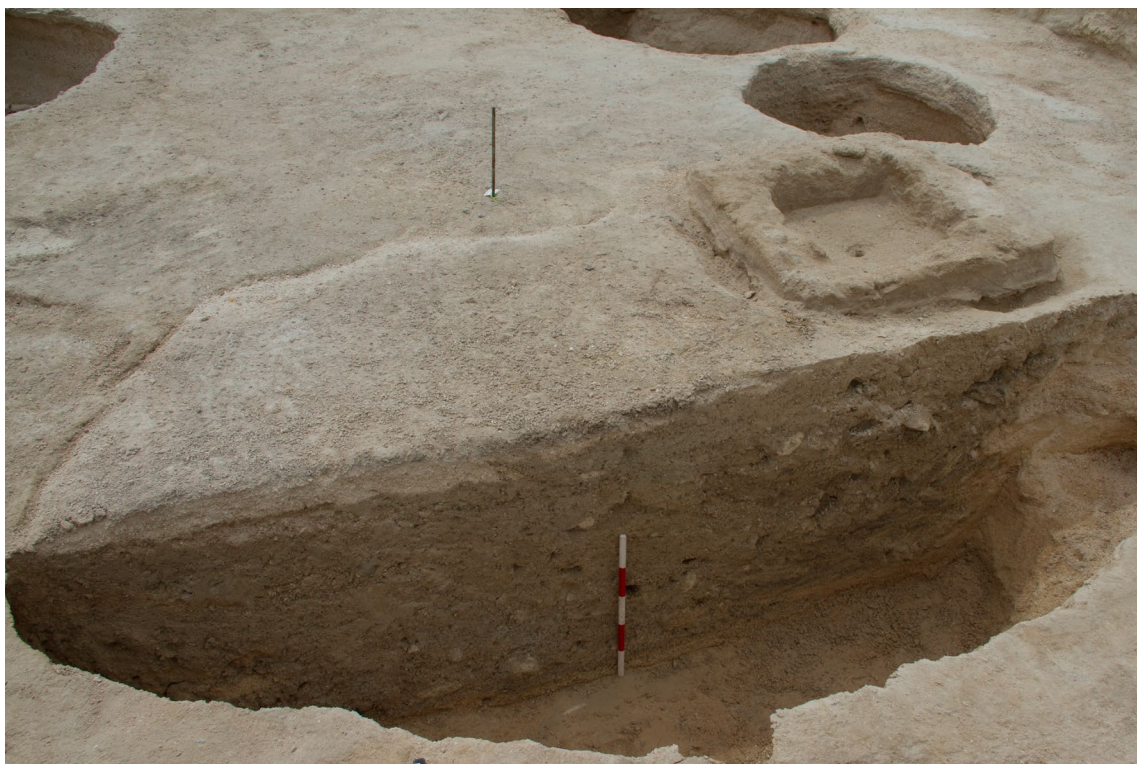
Figure 2.16: Half sectioned pit [4850] containing water basin <4391> in Space 3012, looking southwest. (ME-0178)

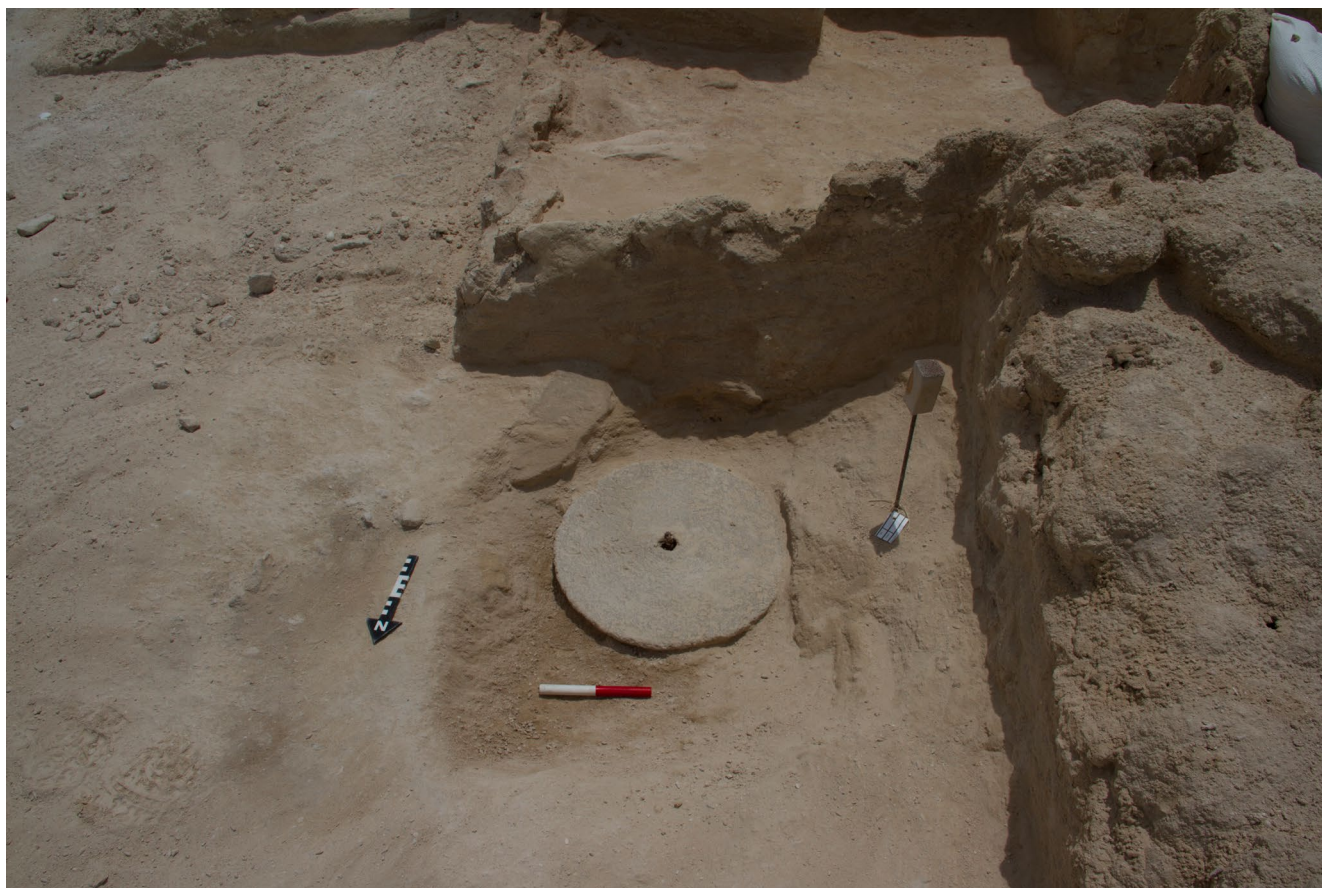
Figure 2.17: Grindstone <4983> directly north of Space 3044, located in the far south-western corner of courtyard Space 3039; looking south. (ME-0809)

PS7 also revealed important tangible signs of occupation. Pottery spreads were located in the south-western corner of courtyard Space 3039. These bore a striking similarity to the spreads found outside Spaces 3017 and 3016 in PS8, and were interpreted as smashed water storage jars. A large grinding stone (Figure 2.17), located directly outside Space 3044, indicates activities related to food production. This stone had in fact been left in situ attached to its central vertical metal rod that presumably constrained it to its position in the corner of the courtyard.

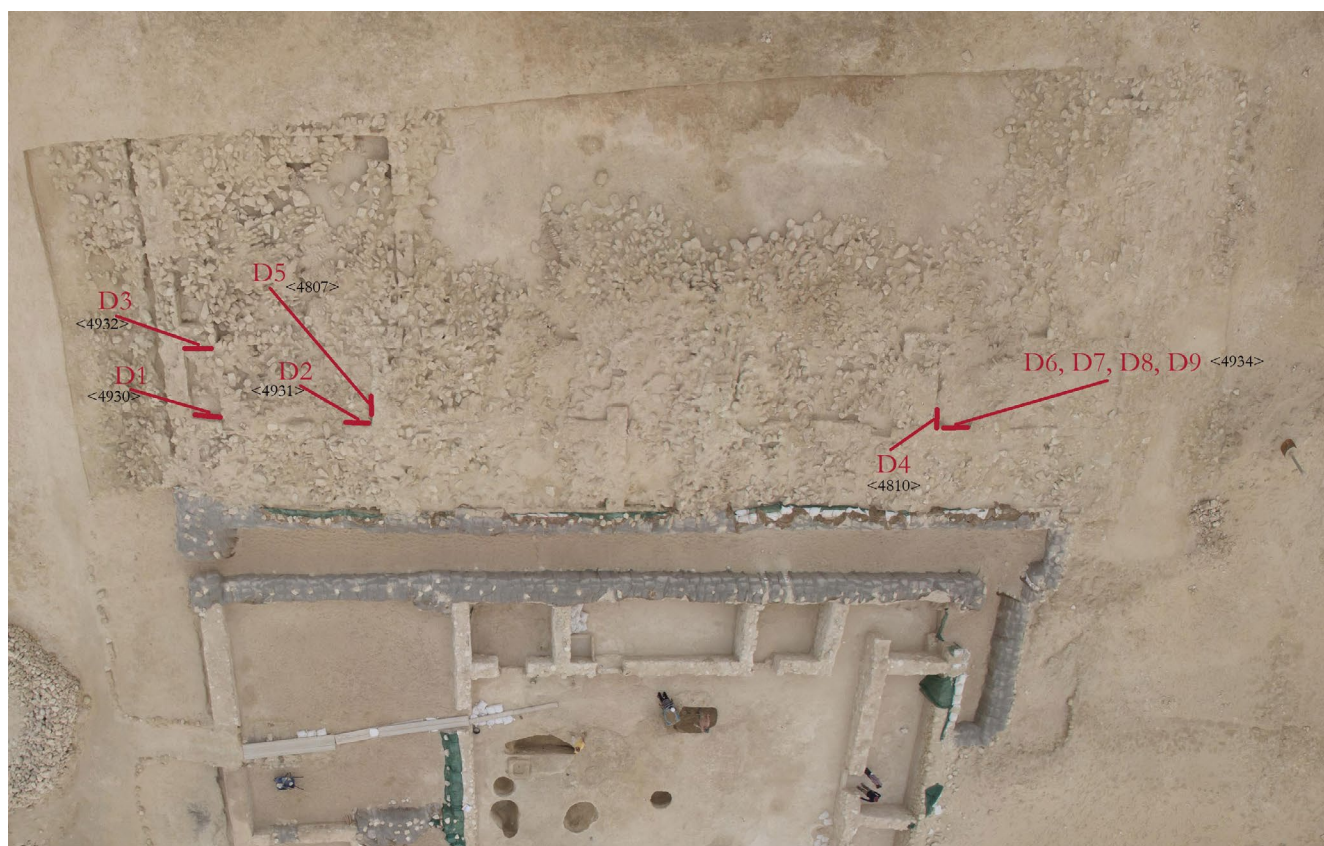
Figure 2.18: Aerial picture of location of graffiti etchings on walls of Precinct Section 7 with dilapidation and demolition deposits from Phase 4. North at top. (IE-0013)

By far the best examples of occupation were the drawings of boats and ships etched into the vertical plaster wall faces found in two of the rooms. Space 3033 displayed signs of four pictures, and a further five were situated in the south-western walls of Space 3036 (Figures 2.18 - 2.20). These graffiti depicted crude images of boats and sailors, and were reminiscent of the larger dhow etching carved into the building wall at ZUEP01 (Sorensen 2009). The etchings had been covered by the rubble collapse of the walls, and therefore must have been made before the general decline of the building. It seemed unusual that such a high-status building would have had such rudimentary images inscribed onto the walls. It was suggested that these were perhaps drawn as Al Zubarah began to fall into decline, maybe when the building was abandoned or when the town itself shrank behind the Inner Town Wall. However, there is no evidence to support this idea as yet, and the etchings very well could have been created during

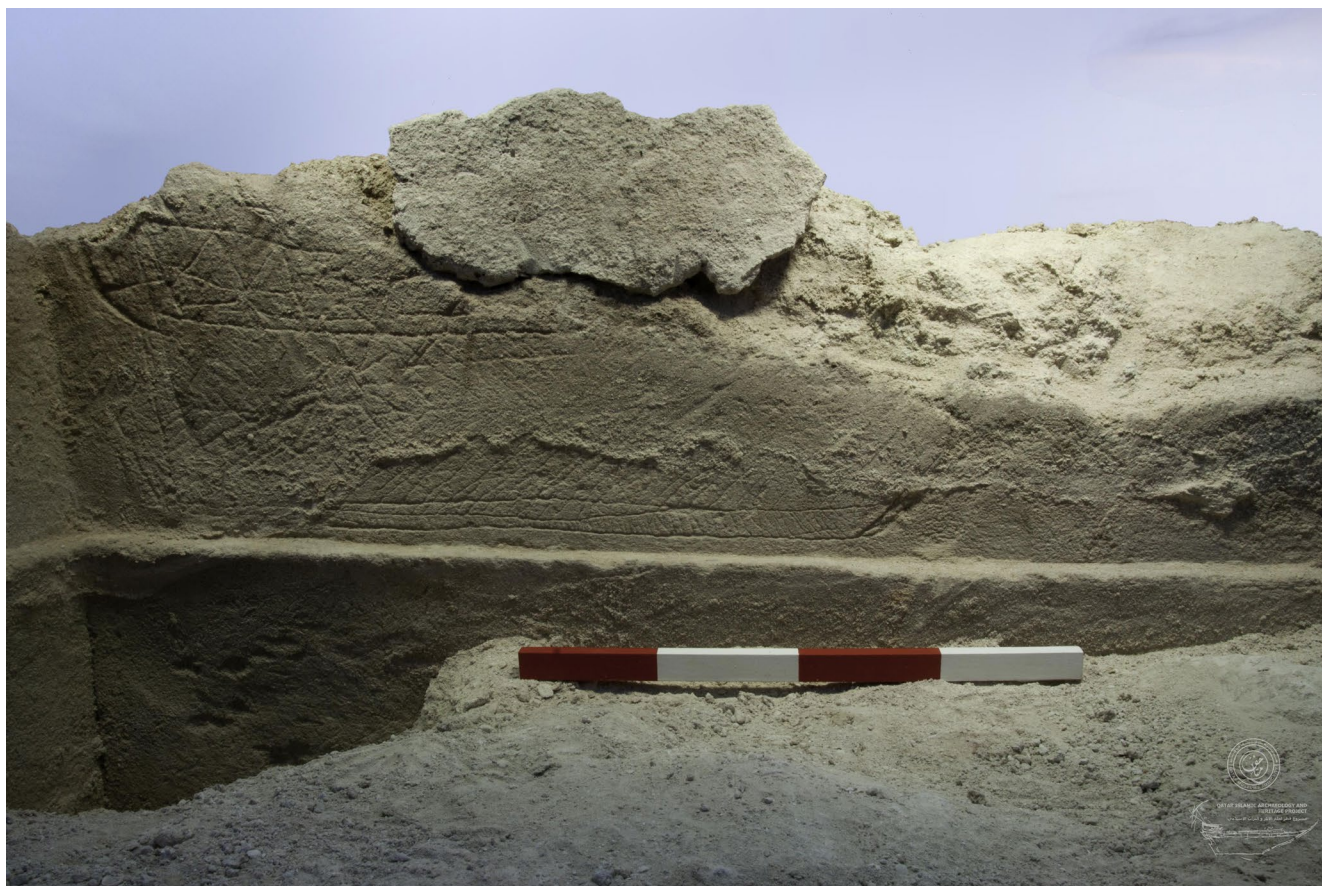
Figure 2.19: Shot of graffiti drawing D4 located in Space 3036. (KE-0036)

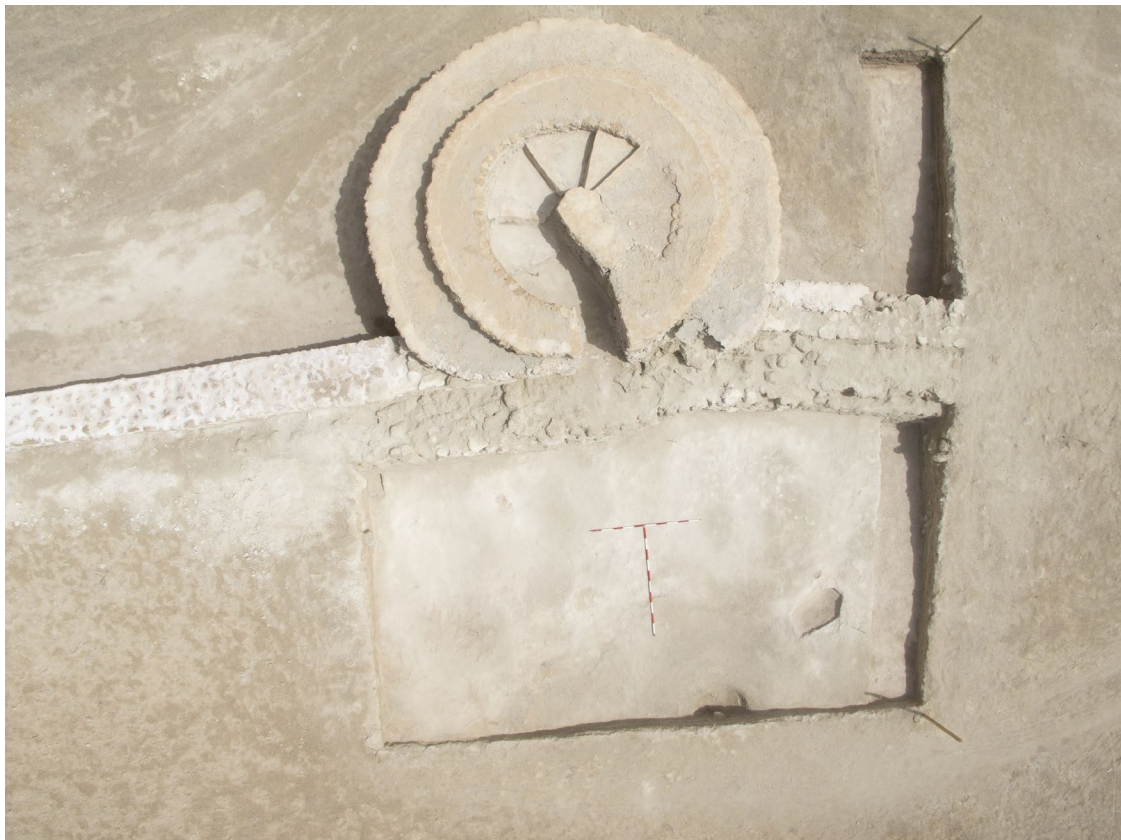
Figure 2.21: Post-excavation aerial view of ZUEP13 with Tower 18. (IE-0017)

Excavation Point 13 (ZUEP13) was opened at the beginning of the 2013 season around the Outer Town Wall (OTW) in the south-east of Zubarah. Running parallel with the wall, approximately northeast to southwest, the area was 10m long and 12.6m wide and focussed on the section of wall surrounding Tower 18 (Figure 2.21).
